Case Study

Vulcan Materials

Mission Valley – San Diego California.

The Problem – Longitudinal Structural Damage
also known as Critical Junction Failure

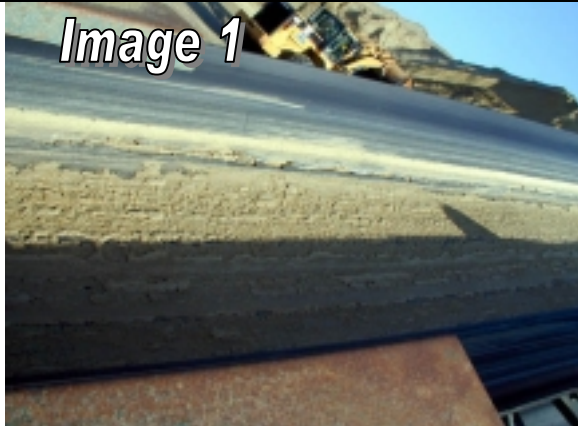
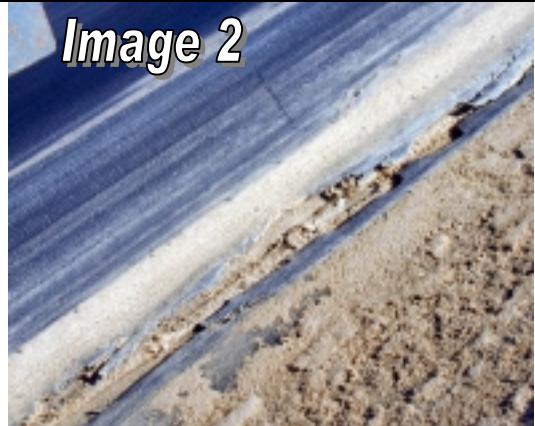
The belt damage consisted of a deep gouge along a 7 foot length of a 150 foot belt. Material was falling through numerous holes causing a safety hazard, dust problems and buildup of material under the belt.

The damage was caused by age and running material with excessive weight over a belt with an idler configuration designed to handle a lighter load.
